The Right Guy Maintenance cc

Negative Side Concrete Waterproofing Product Demonstration in Cape Town. Date : 18 October 2013

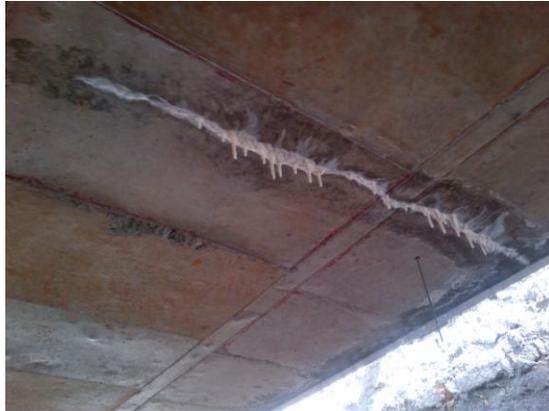
The stalactites on the selected demonstration area are still dripping from upper slab saturation.

We selected an approximate 2m long cracked and leaking underside section of concrete roofing so that a dual product demonstration could be carried out. The application being demonstrated here is a cement based slurry that contains micro crystals that are moisture activated and which proceed to grow inside cracks in concrete up to 1 meter from the point of application.

The right hand side half of the crack is properly prepped and repaired whilst the other half of the crack is just treated with the active crystal slurry.

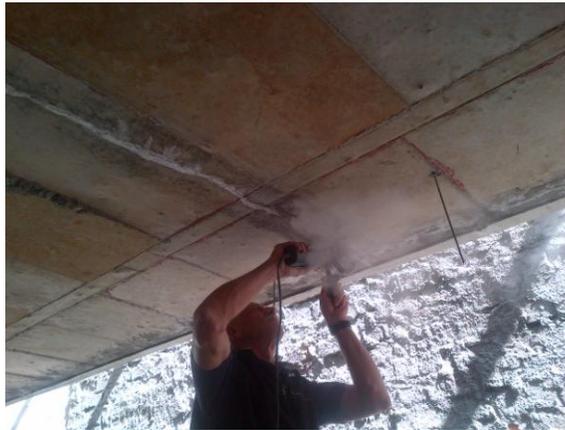
The still actively leaking crack is chased for preparation before the two stage product application.

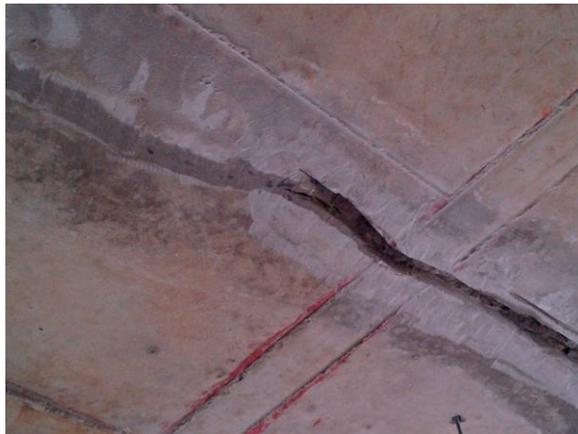
Chased area cleaned and “polished” before the next step in the process. Note how wet the prepared sections still are from the water that is still actively seeping through the crack.

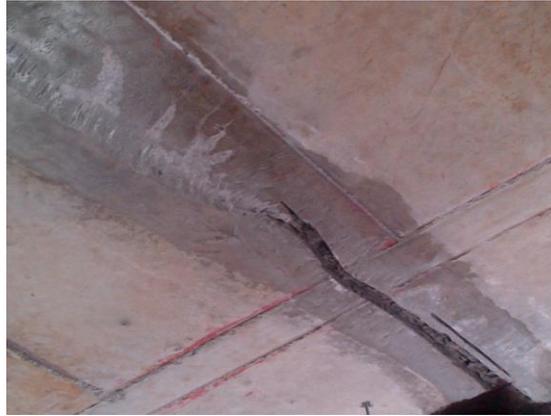
The chased crack route has been cleaned and further saturated to facilitate product activation once it is applied.

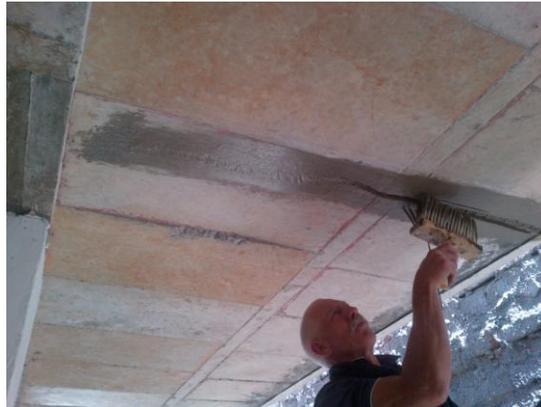
The active crystal slurry is applied as base coat before application of supportive specific repair mortar.

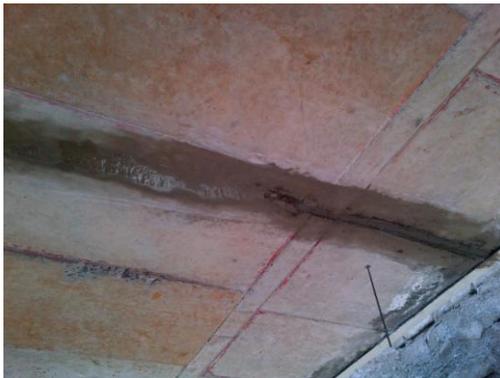
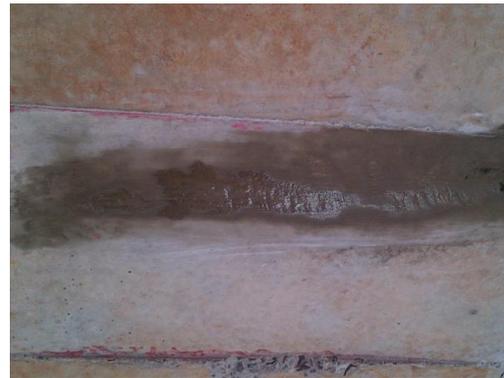
Specialized repair mortar is then applied to the chased section. I want to draw your attention the amount of water still seeping through the slab to the left of the image where the repair area was not chased, but merely coated with the active crystal slurry which is already diminishing.

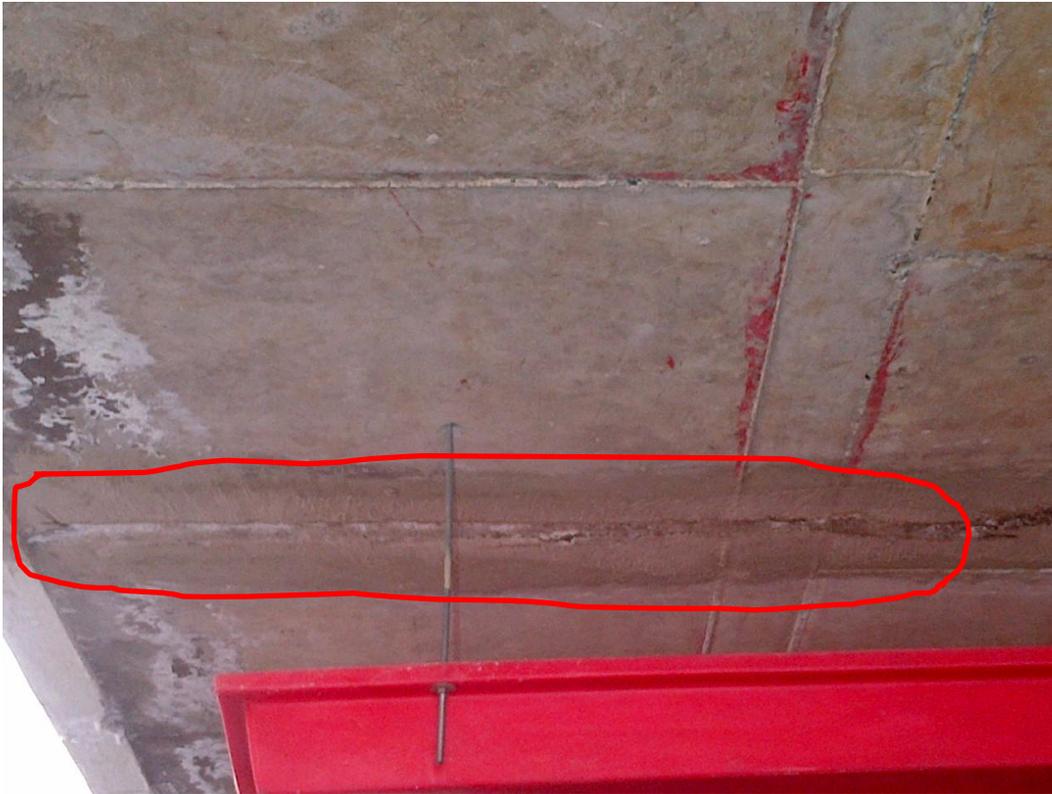
After only four days the thoroughly repaired side of the crack is 100% dry on the negative or bottom side.

The section merely painted with the active crystal slurry is already 90% dry and will be 100% dry in the next few days once the crystals have sufficiently grown inside the crack in the slab.

The repaired area was then left for the product to react to its surroundings for a period of four days.
